NASA TN D-3456

PROJECTILE-IMPACT-INDUCED FRACTURE OF LIQUID-FILLED, FILAMENT-REINFORCED PLASTIC OR ALUMINUM TANKS

by Francis S. Stepka Lewis Research Center Cleveland, Ohio

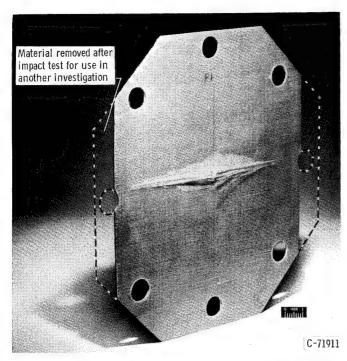
mens (tests 1 and 2, respectively, table I) resulted in only a penetration of the specimens and delaminations of the outer filament layer of the specimens in the vicinity of the impact. The results of the impact into the 0.125-inch-thick specimen are shown in figure 4. Before a photograph of the complete specimen was made, a portion of the specimen material had been removed after the impact for use in another investigation. An outline of the portion removed is shown with dashed lines.

Figure 4. - Impact into unstressed 0.125-inch-thick glass-reinforced epoxy specimen wall on water-filled tank (test 1). Impacting projectile, 7/32-inch-diameter aluminum sphere; velocity, 6500 feet per second.

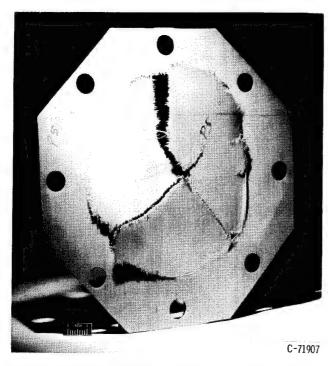
Dacron-filament-reinforced urethane specimens: An impact made with a 7/32-inch-diameter steel sphere at a velocity of about 5500 feet per second into a 0.063-inch-thick sheet specimen of Dacron-reinforced urethane pressurized to 50 pounds per square inch gage (wall stress, about 8000 psi) resulted in a puncture and a local delamination of the outer filament layer (test 4), as shown in figure 5. When the initial stress before impact in two other Dacron-reinforced specimens (tests 5 and 6) was increased to about 12 800 pounds per square inch (by a liquid pressure of 100 psig), impact by a projectile resulted in catastrophic fracturing of the specimens, as shown in figure 6 for test 5.

Figure 6. - Impact into 0.063-inch-thick Dacron-reinforced urethane specimen wall on liquid-nitrogen-filled tank pressurized to 100 pounds per square inch gage (test 5). Impacting projectile, 7/32-inch-diameter steel sphere; velocity, 5500 feet per second.

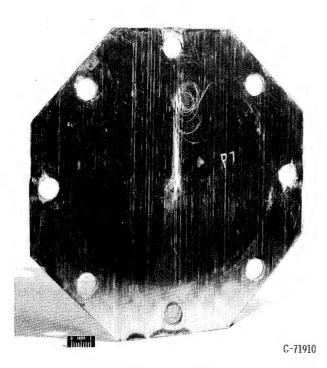
0.032-inch-thick sheets of steel-wirereinforced urethane (tests 7 to 9) resulted in only a hole and local delaminations of the outer layer of the wire in the vicinity of the hole. Prior to impact, these specimens were pressurized internally to values of 100 to 175 pounds per square inch gage, which resulted in wall stresses of 28 500 to 30 000 pounds per square inch, respectively. Impact into the remaining specimen with a 0.032-inch-thick wall that was pressurized to 175 pounds per square inch gage (test 10) resulted in large areas in which the wire layers were delaminated. The results of impact into two of these specimens (tests 7 and 10) are shown in figure 7 and 8, respectively.

Figure 7. - Impact into 0.032-inch-thick steel-wire-reinforced urethane specimen wall on liquid-nitrogen-filled tank pressurized to 100 pounds per square inch gage (test 7). Impacting projectile, 7/32-inch-diameter steel sphere; velocity, 5500 feet per second.

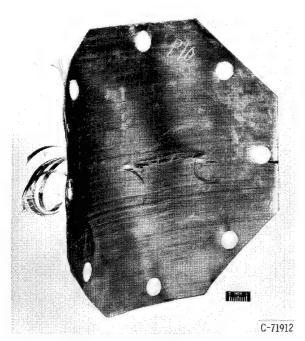
Figure 8. - Impact into 0.032-inch-thick steel-wire-reinforced urethane specimen wall on liquid-nitrogen-filled tank pressurized to 175 pounds per square inch gage (test 10). Impacting projectile, 7/32-inch-diameter steel sphere; velocity, 5500 feet per second.

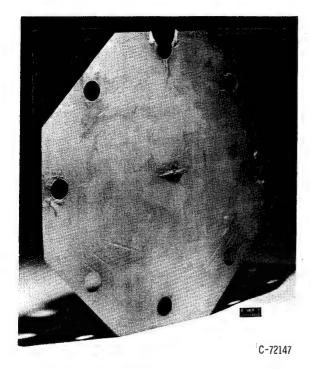
to 0.023-inch thickness (tests 11 to 13) that were impacted after the wall had been initially stressed to levels of 26 700 to 39 800 pounds per square inch (liquid pressures 50 to 125 psig) resulted in only a hole and local delamination of the outer filament layer. Impact into a specimen 0.023 inch thick and pressurized to 175 pounds per square inch gage to induce a wall stress of about 43 500 pounds per square inch (test 14) resulted in local delamination of the outer filament layer and a tearing of the wall extending about 3/4 inch from the edge of the hole (fig. 9). Further testing of the sheet specimens at higher stress levels was impossible because of yielding in the specimen material surrounding the bolt holes.

Figure 9. - Impact into 0.023-inch-thick glass-reinforced epoxy specimen wall on liquid-nitrogen-filled tank pressurized to 150 pounds per square inch gage (test 14). Impacting projectile; 7/32-inch-diameter steel sphere; velocity, 5500 feet per second.

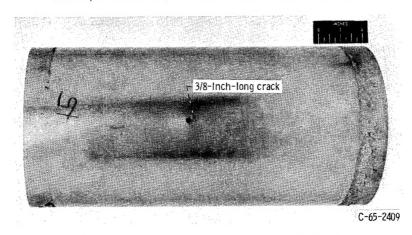
Impacts into one of the tanks with a 0.032-inch wall thickness with an initial static tank wall-stress - ultimate-strength ratio of 0.1 (test 24) resulted in a catastrophic bursting (fig. 11(a)). The result of impact into the same thickness tank without any initial pressurization (test 25) resulted in a hole and a small crack (about 3/8-in. long) at the edge of the hole (fig. 11(b)). Impacts into the tank with a 0.063-inch-thick wall stressed to 30 percent of the material ultimate strength prior to impact (test 26) and into the two tanks with the 0.081-inch wall thickness stressed to 33 and 50 percent of the material ultimate strength (tests 27 and 28) resulted only in holes in the tank walls. Increasing the wall stress to 58 percent of the ultimate for the tank with the 0.084-inch-thick wall (test 29) resulted in catastrophic bursting of the wall as a result of projectile impact.

(a) Tank pressurized to 10 percent of ultimate stress before impact (test 24).

(b) Tank without any initial pressurization prior to impact (test 25).

Figure 11. - Results of impact into 0.032-inch-thick, 7.5-inch-diameter 2014-T6 aluminum tanks filled with liquid nitrogen. Impacting projectile, 7/32-inch-diameter steel spheres; velocity, 5500 feet per second.
